Hi-tech approach to predictive maintenance

A CASE STUDY AT ISKI (WATER UTILITY)

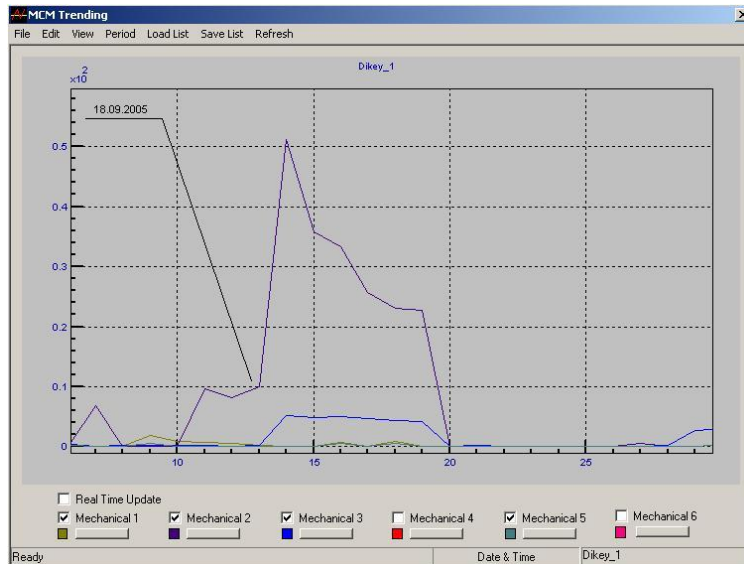
Following the alarms that came from MCM, starting September 18th, an increase was noticed on the mechanical parameter (Mechanical parameter 2) with an increased trend. The operation & maintenance team analyzed the situation using the output that MCM has provided, and determined that the nonreturn valve was broken and the broken nonreturn valve was replaced before failure. After the maintenance work that was done at the same day, it was noticed that the mechanical parameters went back to their normal values, and the system started to work with its previous performance. As a result, an unplanned breakdown was avoided.

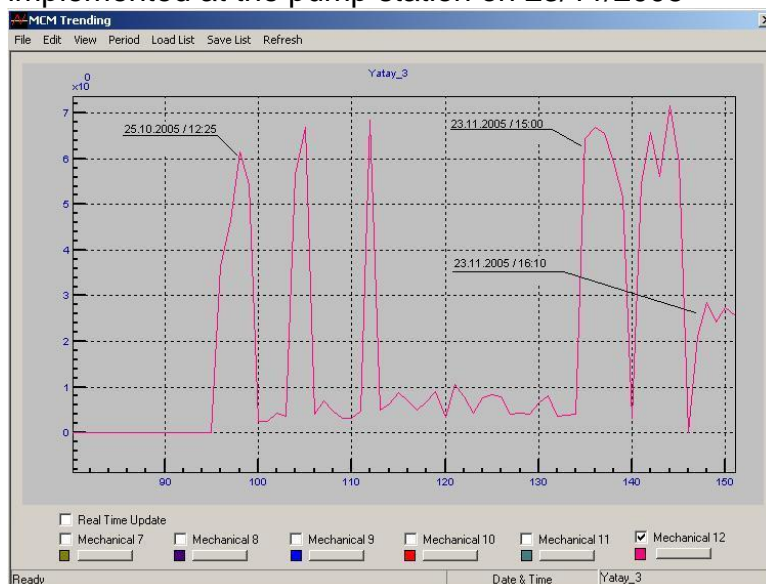
After the analysis, one thing to note was that the 12th mechanical parameter on vertical pump #3 has been showing high values. After the analysis, it was concluded that the rise in this parameter, that points to cavitation, is not at the sufficient level to trigger the alarm, however the high values show that the pump housing and shaft might be damaged soon if the situation continues. The diagram (below) shows the cavitative effect on the vertical pump #3 while it is in operation on the tests that were implemented at the pump station on 23/11/2005
